# Manhole Inspection Summary

Manhole # S2900\_003MH

Insp Date: **7/9/07 8:58 AM**

**Location** Address: **2204 MOUNT ROYAL TERR**

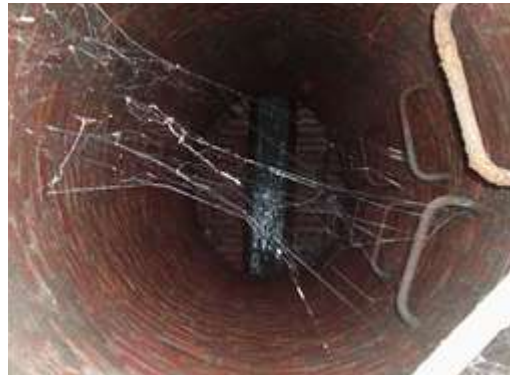
Top View

**Steps** Count: **10** Missing: **0** ☒ **Corroded**

Corroded steps.

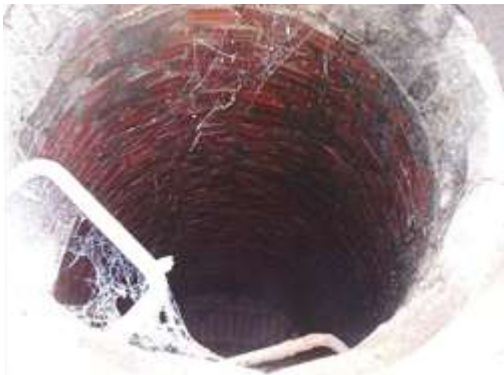
Defect

**Frame** Offset: **0.5** (in.) Condition: ☐ Sound ☐ Cracked ☒ **Leaks**

Condition: ☐ Sound ☐ Cracked ☐ Root Intrusion ☒ **Loose Brick** ☒ **Deteriorated**

Infiltration: ☐ None ☒ **Joint** ☐ Cracks ☐ Mortar ☐ Roots ☐ Wall

Infiltration: ☐ None ☐ Joint ☐ Cracks ☒ **Mortar** ☐ Roots ☒ **Wall**

Frame leaks. Frame offset. Adjustment deterioration, loose brick and infiltration. Corbel infiltration - other side.

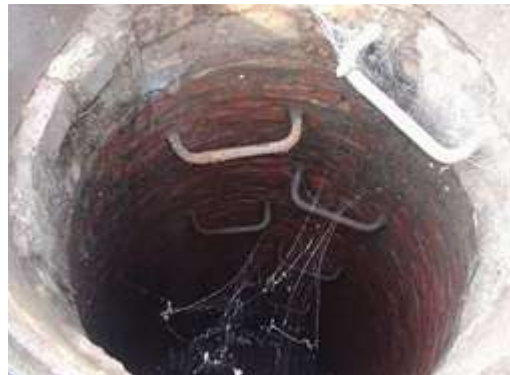
Defect

Frame leaks. Frame offset. Adjustment deterioration, loose brick and infiltration.

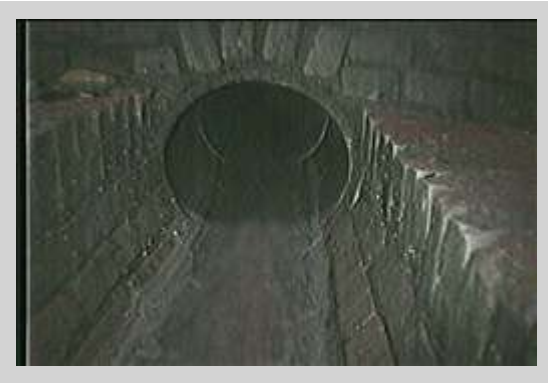
### 10 in. Circular Gravity Sewer Pipe Out @ 12 O'Clock

Condition: ☐ Sound ☐ Cracked ☐ Root Intrusion ☒ **Deteriorated** ☐ Leaks ☐ Debris

Channel deterioration.
